Bruxzir™ Crown Restoration in a Dog

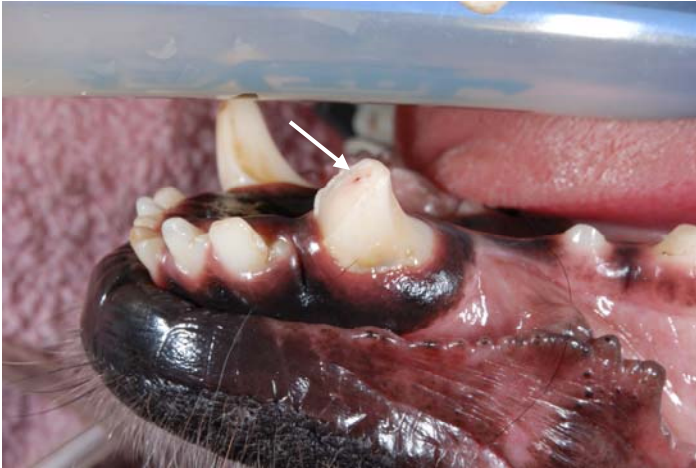
A complicated crown-root fracture was found at the left mandibular canine tooth.
